123456 Main Blvd Portland, OR 97245

Prepared by: The House Detectives, LLC PO Box 216

# The House Detectives, LLC Sample Report.inspx

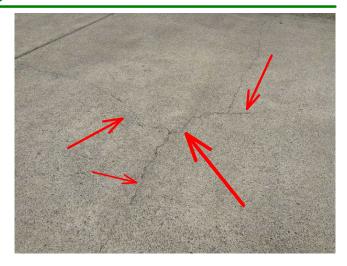
Serviceable Driveway: Concrete - Common Cracks

Serviceable Walks: Concrete - Common Cracks

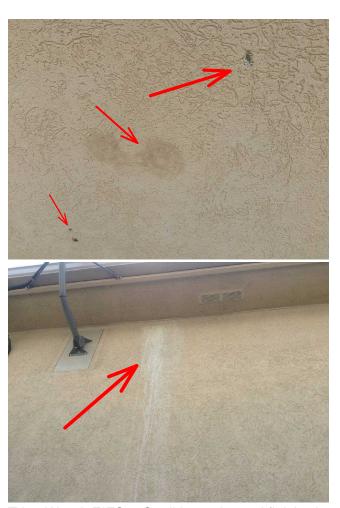
Maintenance Repair Trim: Wood, EIFS - Caulking paint and finished needed, Evidence of prior repairs to the south side of the residence building

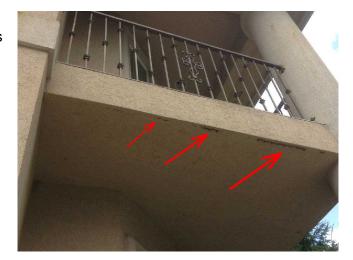
Maintenance Repair Fascia: Wood - Paint is worn / peeling Maintenance Repair Soffits: Wood - Damaged paint finish, Damaged, Siding damage at front columns from bird damage

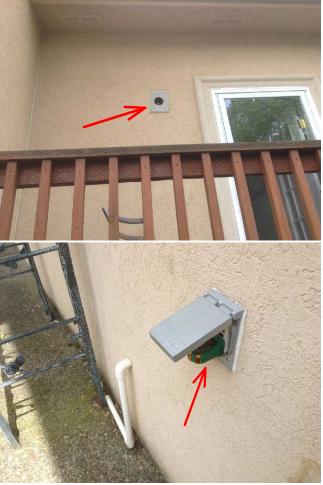
Maintenance Repair, Safety Hazard Exterior Electric Outlets: 110 VAC GFCI - Loose or missing moisture cover,

Exposed wiring present, Inoperative at time of inspection

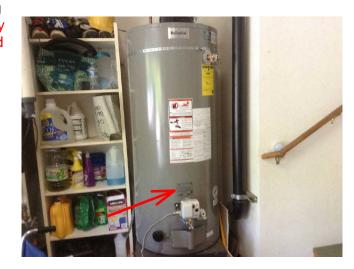
Serviceable TPRV and Drain Tube: Drain tube missing Maintenance Repair, Safety Hazard Seismic Strap Metal - Only

one seismic strap provided

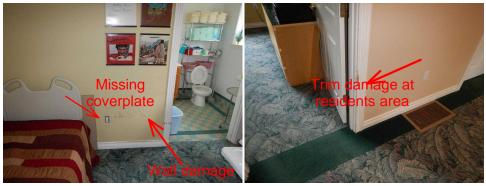
Maintenance Repair Walls: Painted Drywall - Minor drywall repairs needed at residence area, kitchen, and bedrooms

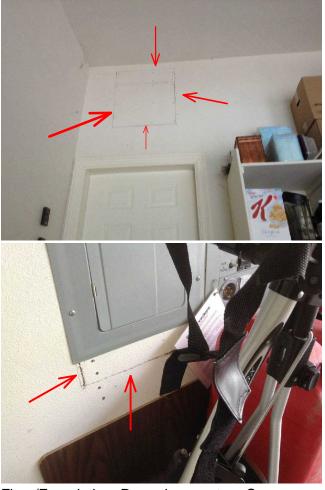
Maintenance Repair Walls: Painted Drywall - Seal holes in drywall to restore fire separation barrier
